HIGH SPEED POSITION

SERVICING THE DR2 WIPER

SERVICING THE DR1 AND DR2 WIPER ASSEMBLIES

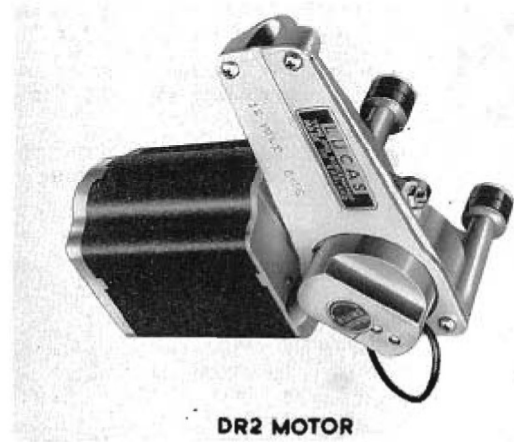
THE DR2 EXTERNAL VIEW

The DR2 is the new model in the DR range, being basically similar to the DR1, and designed to give approximately the same performance. It is suitable for 6, 12 and 24 volt working, with varying angles of wipe from 90° to 130°.

The models so far fitted to vehicles are constructed for single speed operation only.

The DR2 is not thermostatically controlled, since the motor is designed to withstand stall currents for a considerable time.

A different arrangement for self-parking allows a simple ON/OFF panel control switch to be used.

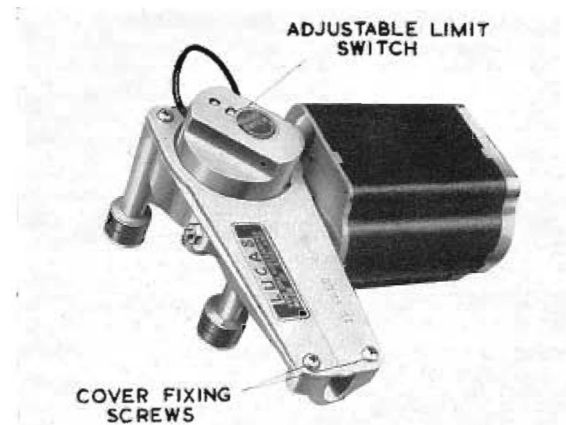
THE LIMIT SWITCH ADJUSTMENT

The limit switch is adjustable, enabling the correct parking position to be obtained.

The switch assembly is released by slackening off the four cover fixing screws. It should then be turned and set so that the motor switches off just after the blades have finished their downward travel and are starting the upward stroke.

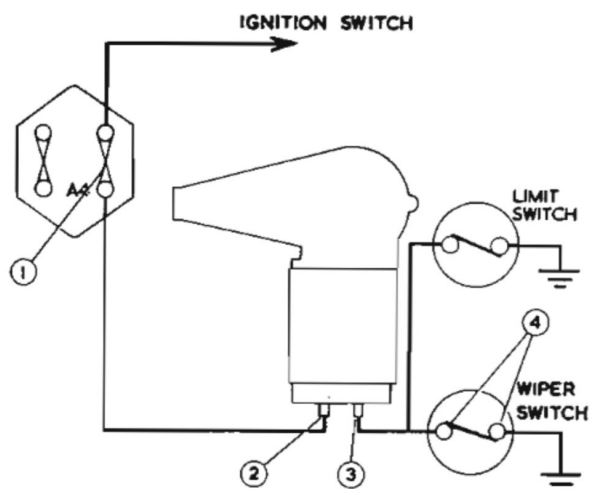
CIRCUIT TESTING — VOLTMETER TEST

Switch on the ignition and ascertain that current is available at the A4 fuse. This can be easily checked by the voltmeter. With the wiper motor switched OFF we should also have full voltage readings at the wiper motor terminals 2 and 3 in the picture. At the same time when the wiper switch (4) is moved to the ON position the voltage registered at (3) should disappear. If it does not, the wiper switch itself or the earth point is faulty.

If no voltage is registered at the points mentioned it is a simple matter to trace the open circuit by following the wiring sketch shown.
